ARIZONA GEOLOGY

THE HORSESHOE FAULT

Evidence for Prehistoric Surface-Rupturing Earthquakes in Central Arizona

by Lucille A. Piety and Larry W. Anderson

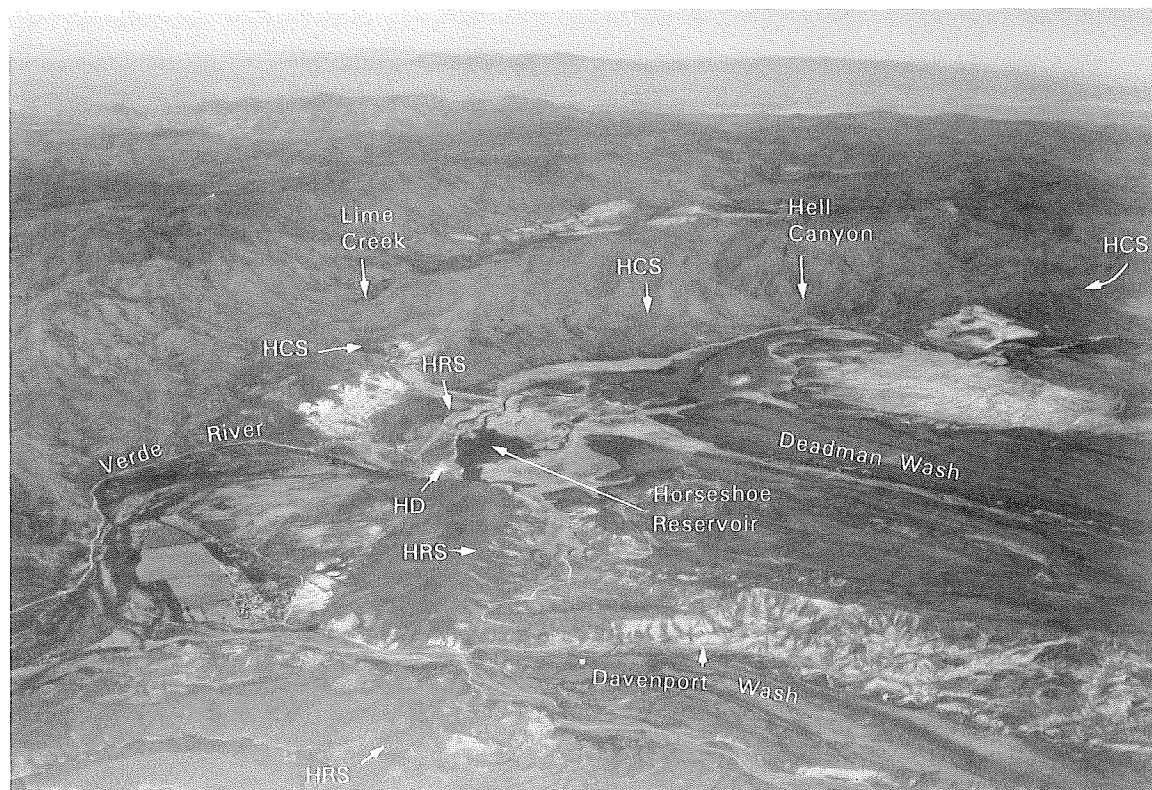
Figure 4. Aerial view toward the northwest of the two segments of the Horseshoe fault. The Hell Canyon segment (HCS) trends along the range in the middle ground. The Horseshoe Reservoir segment (HRS) trends away from the viewer toward the Hell Canyon segment. Horseshoe Dam (HD) is partially concealed in the middle ground.

The Hell Canyon segment separates Precambrian granitic rocks that form the unnamed mountain range west of the fault from the Tertiary sedimentary and volcanic rocks that fill Horseshoe basin (Figures 3 and 4). This fault segment, which is 11 to 12 kilometers long and dips eastward beneath the basin, was recognized by earlier workers (Erte, 1981; Morrison and others, 1981; Menges and Pearthree, 1983; Pearthree and

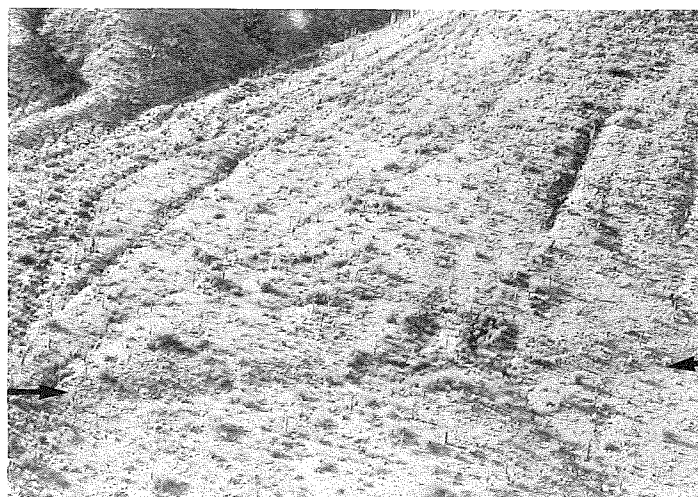
Figure 6. Aerial view toward the west of a linear east-facing scarp (between arrows) along the Hell Canyon segment of the Horseshoe fault between Lime Creek and Hell Canyon (Figures 3 and 5). The displacement of the alluvial-fan surface across this scarp is about 2 meters. The slope of the alluvial-fan surface is 10° to 13°; the maximum slope of the scarp is about 27°.

Quaternary surface rupture is manifested by scarps on the relatively smooth surfaces of alluvial fans estimated to be of Pleistocene age (between 2 m.y. and 10,000 years old). These alluvial fans are composed of boulders, cobbles, and sand eroded from the adjacent range. Their surfaces slope 1° to 13° toward the Verde River away from the range front, except where the scarps abruptly steepen the slopes to 10° to 27°. The scarps, which are preserved discontinuously along some 9 kilometers of the Hell Canyon segment, displace the alluvial-fan surfaces from 2 to 5 meters (Figures 3 and 6). The scarps' alignment with the faulted contact between the Precambrian and Tertiary rocks and their roughly perpendicular orientation to drainages that issue from the range strongly indicate that the scarps were formed by surface-rupturing earthquakes along the fault rather than by erosion along the drainages that flow into the Verde River.

The scarps demonstrate that the Hell Canyon segment has experienced at least one, and possibly as many as three, strong earthquakes since the alluvial fans were deposited. Unfortunately, the ages of these alluvial fans could not be determined with any precision. Characteristics of the scarps themselves, however, suggest that at least one, and probably two, surface ruptures occurred during the late Quaternary (within about the last 150,000 years). The scarps are straight, relatively steep (maximum slope angles between 10° and 27°, with scarp heights of 2 to 7.5 meters), and not markedly dissected or modified by stream erosion. In other areas of the western United States, where scarps have been dated through the use of radiocarbon techniques or by the identification of volcanic ash layers, scarps with the above characteristics are thought to have formed during the last 30,000 to 15,000 years (Wallace, 1977; Bucknam and Anderson, 1979). Because scarp characteristics are influenced by many factors besides age, direct comparison of these characteristics among areas with different climates, rock types, or erosion rates is questionable. The straightness, steepness, and location of the scarps near the base of the range front, however, suggest that only limited erosion has occurred along this fault segment since the most recent surface-rupturing earthquake. From these characteristics, we infer that at least one, and probably two, surface ruptures took place on the Hell Canyon segment during the late Quaternary; the most recent rupture may have occurred during the last 30,000 to 15,000 years.
